SINTEF

SMARTER - Surveying microplastic release from aquaculture nets and ropes using different technologies for emission reduction

2025:00574 - Unrestricted

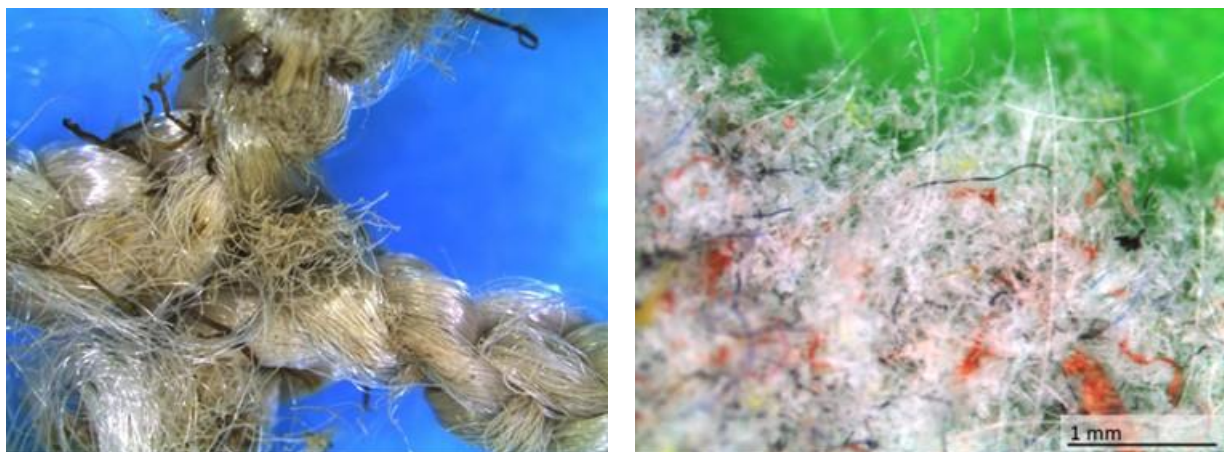
Figure 1: Wear on aquaculture nets from high pressure cleaning (left). Microplastics collected from abrasion testing of various materials for fishing gear (right, FHF-project 901669). Photos: Heidi Moe Føre, SINTEF Ocean.

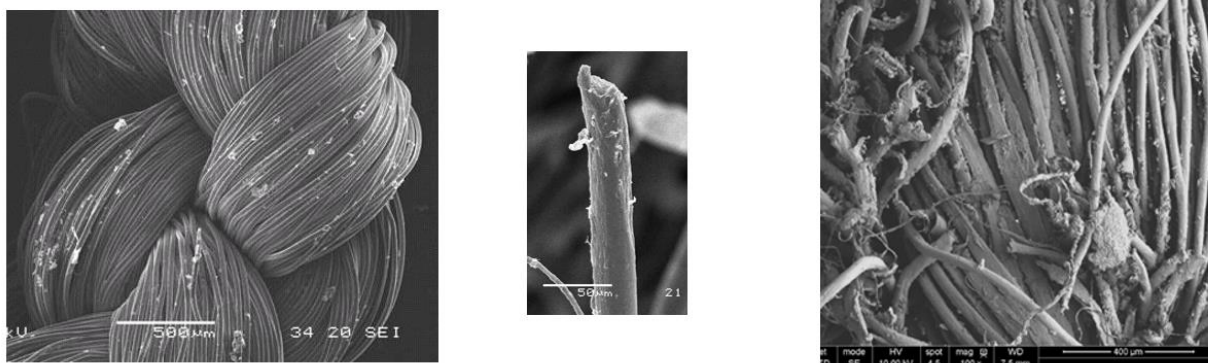
Figure 3: Electron microscopy images. From left to right: netting twine with undamaged fibres, cut fibre, area of netting with abrasion damage (probably from contact with high pressure cleaner disc).

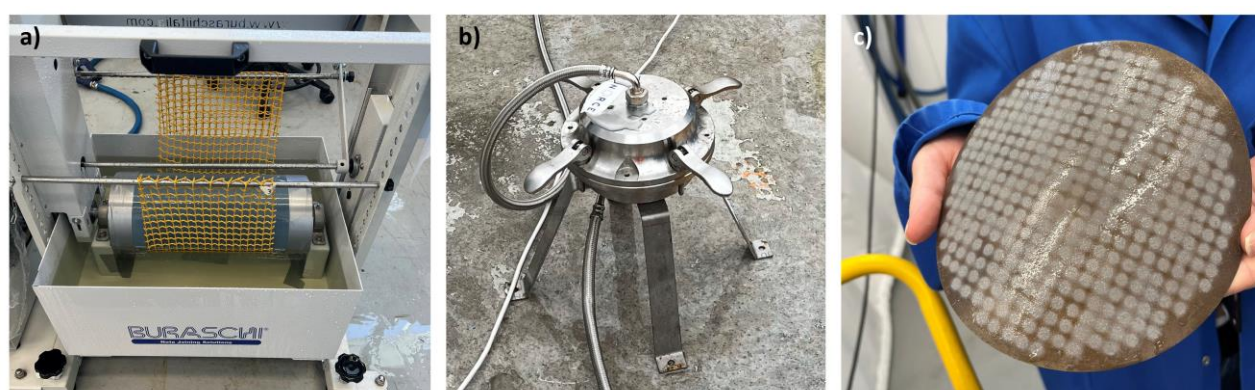
Figure 4: a) Buraschi abrasion equipment, b) the NORCE filtration unit used for all MP sampling, and c) a filter with collected particles.

To assess the effects of net material, coating, and net age on MP release, standardised abrasion tests were conducted in the laboratory using an abrasion machine specifically designed for nets and ropes (MILA 200 WET, Buraschi Italia).¹⁴ The device features a rotating drum with a circumference of 63 cm covered with an abrasive surface and a water tank, allowing tests to be performed under wet conditions (Figure 4a).

Abrasion tests were conducted on three replicate samples per net type. Each sample measured approximately 35 × 100 cm and was pre-conditioned by soaking in freshwater for at least 16 hours prior to testing. The abrasion setup consisted of a cylindrical drum system with an abrasive surface and circulating water. The water filtration system to collect the MP particles consisted of a pump connected to a filtration unit (NORCE filtration unit, Figure 4b,c).

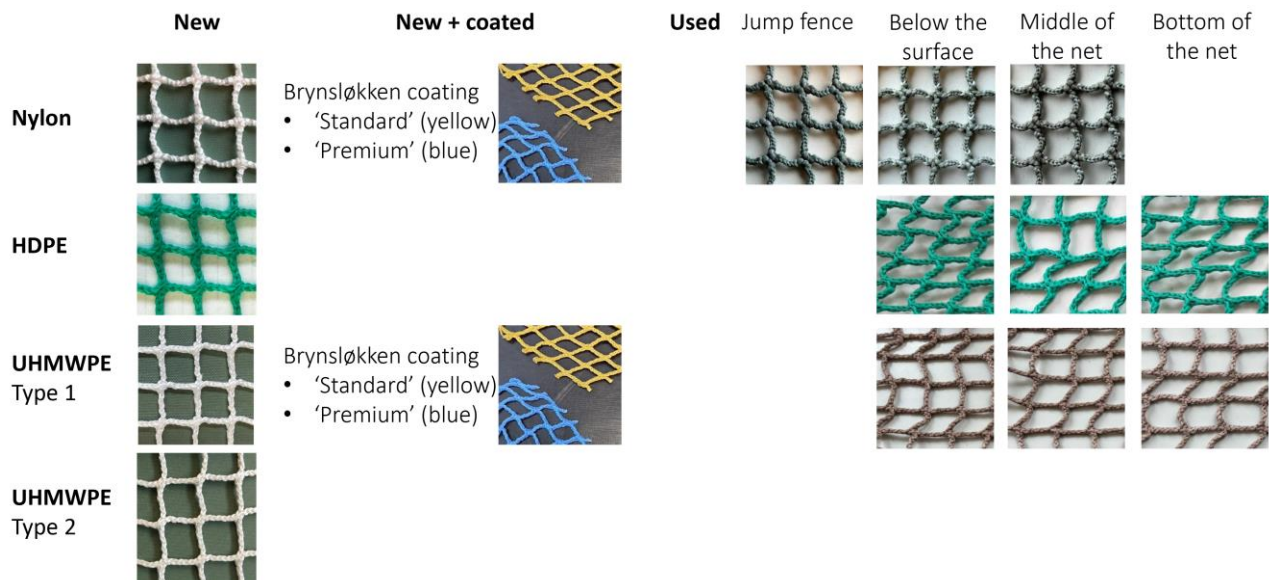
Figure 5: Four net materials in three conditions included in laboratory MP production experiments.

The test included four different net materials (Table 1): nylon, HDPE, and two types of UHMWPE. All materials were tested in their new, unused state. Additionally, nylon and UHMWPE were tested with both standard and premium Brynsløkken coatings applied to unused nets (Figure 5).

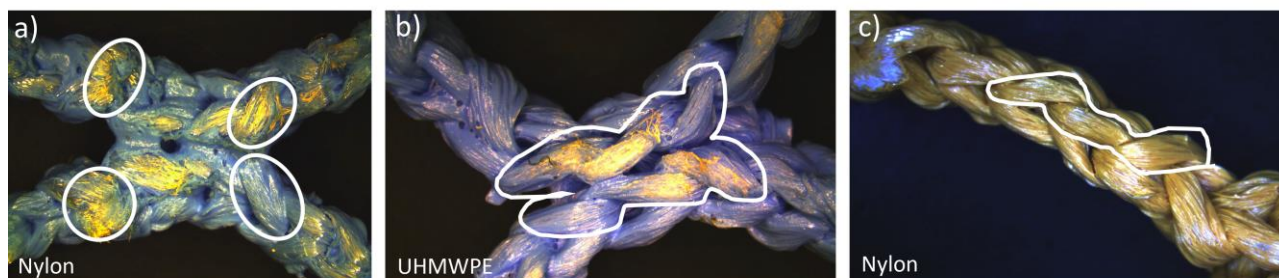
Figure 6: Net strands chosen for assessment of fibre and coating integrity, located as part of the knot (a, b) or between knots (c).

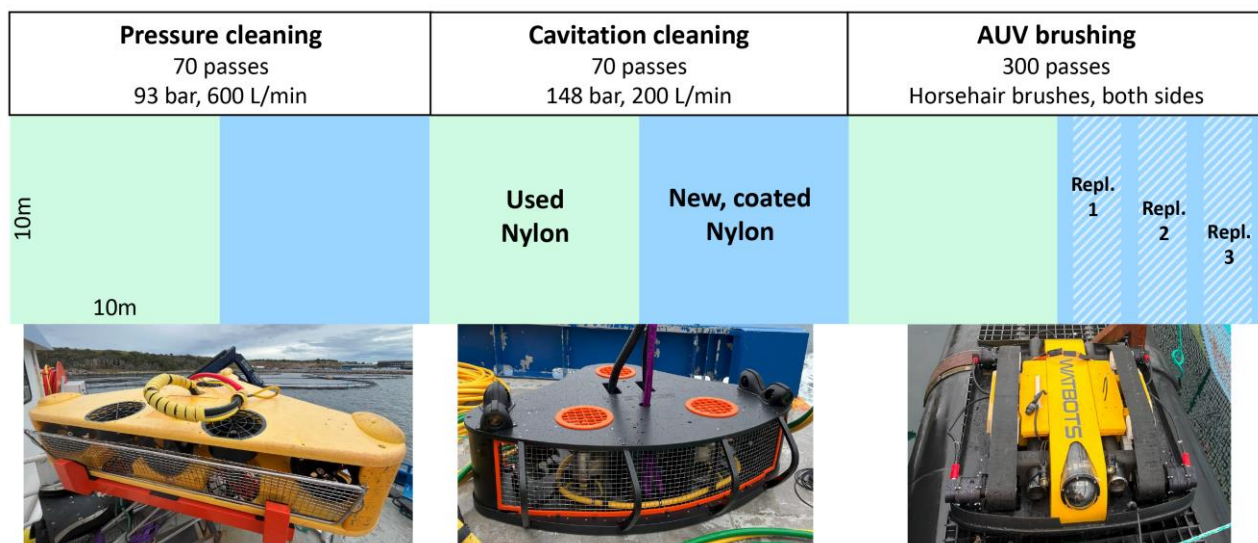
Figure 7: Schematised experimental set-up to simulate 10 months of net cleaning at sea testing three technologies on two net materials.

To enable testing under conditions as close to real-life as possible, a 60 × 10 m test net was constructed, consisting of six 10 × 10 m nylon panels (Figure 7). Three of the panels were made from new nylon netting coated with Brynsløkken premium coating, while the remaining three were cut from a used nylon net. The used net had been deployed at sea for one season and subsequently stored for ten years. Originally coated with copper, panels for the test were harvested from sections located 5 metres below the waterline. The panels were sewn together in an alternating pattern (new/used) and mounted on an empty 159-metre plastic ring at Scale AQ's assembly and decommissioning site in Nordhammervika, Frøya. The net was installed on 30.8.2024. Pressure cleaning was conducted on 2.9.2024, followed by cavitation cleaning a day later on 3.9.2024. AUV brushing was performed a week later, on 9.9.2024 and 10.9.2024.

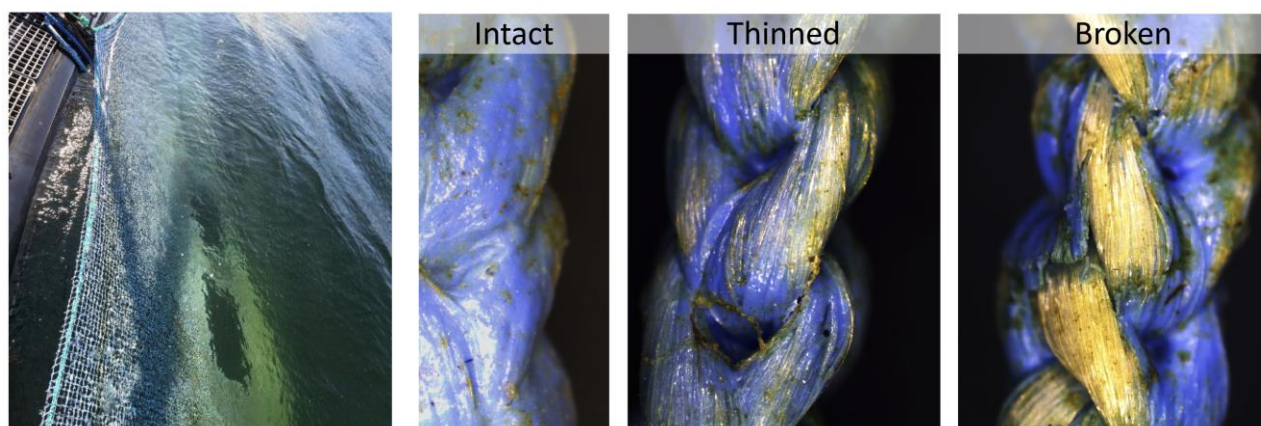
Figure 8: Coating integrity after net cleaning was analysed for samples taken at 3 m depth (left) based on three coating status categories.

1. **Intact coating:** Individual net fibres are not visible beneath the coating layer.
2. **Thinned coating:** Individual nylon fibres are visible, and while some may no longer be fully covered, the net strand remains structurally intact. No obvious edge to the coating is visible.
3. **Broken coating:** Coating is visibly damaged with a distinct edge; white fibres are exposed and, in some cases, no longer held together. This category included a range of expressions that varied depending on the cleaning technology used.

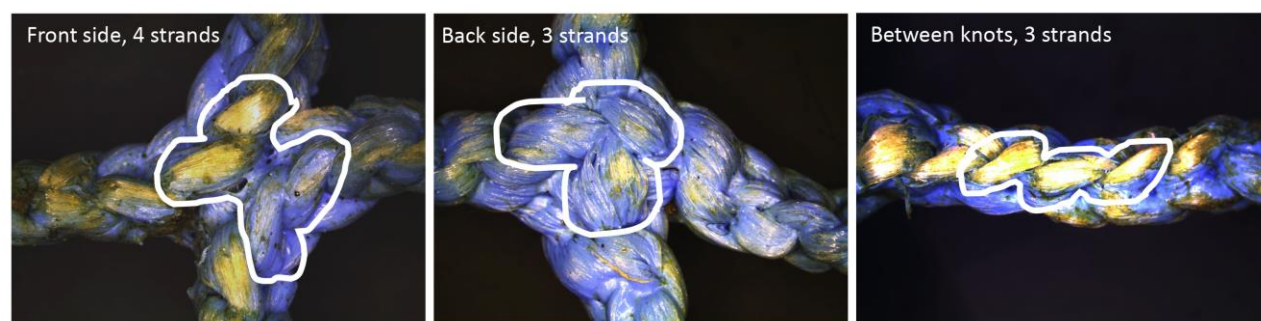
Figure 9: Net strands chosen for assessment of coating integrity located on front and back side of the knot, as well as between knots.

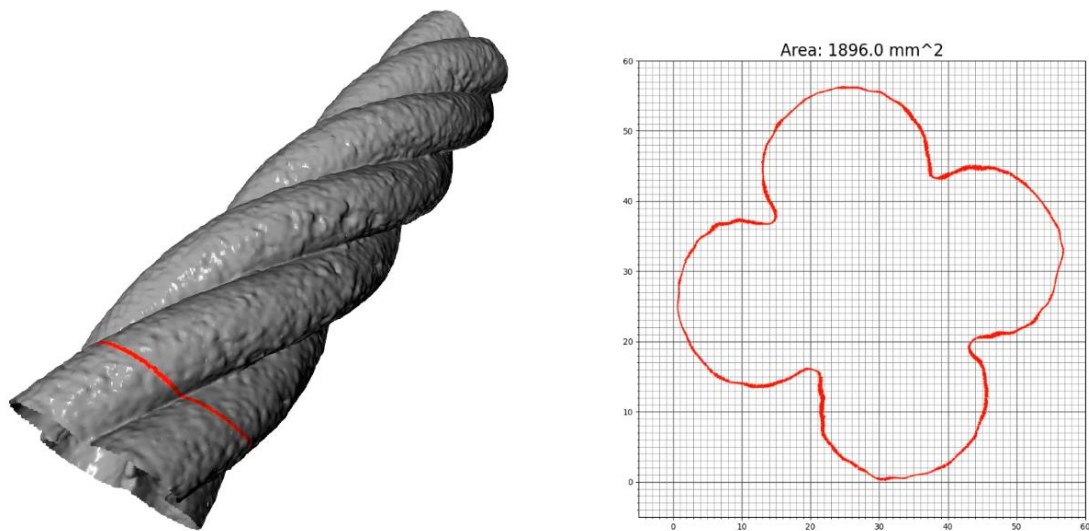
Figure 11: 3D scan and cross sectional area of a 50 mm rope using a Creality Raptor 3D-scanner.

Characterisation of the ropes was performed using two different types of 3D scanner. The goal was to measure a virtual cross-sectional area of the rope and determine the dimensions of the rope more accurately than the manual measurements achieved with vernier callipers. The first scanner was a handheld CR-Scan Raptor scanner from Creality. It uses a hybrid blue laser and NIR and comes with software that claims to deliver very high accuracy. In practice, this scanner had problems mapping ropes of the sizes used in this project and appears better suited for scanning larger objects. Irrespective of the settings used, the software was unable to perform a complete 360 degree scan of the rope. When tested on a larger 50 mm rope (not used in the abrasion studies), the scanner was able to generate good results, as shown in Figure 11.

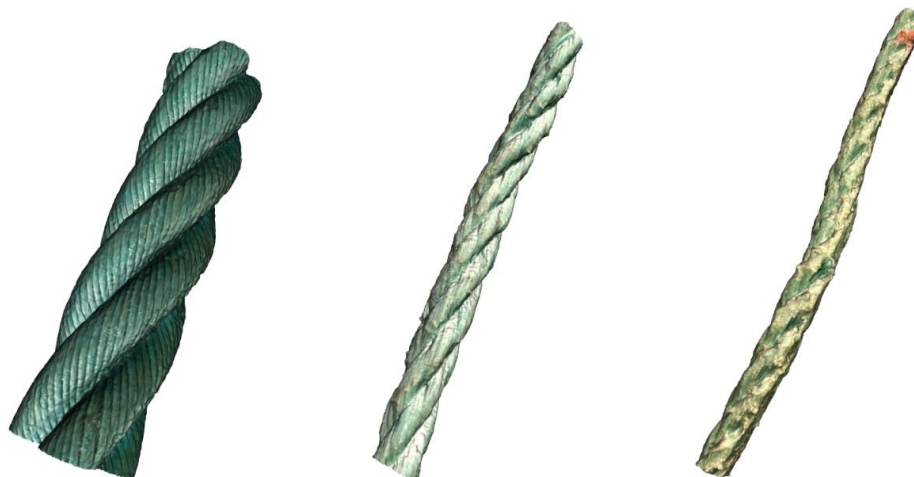
Figure 12: 3D images of ropes from photogrammetry experiments

A photogrammetry method was also tested on the rope samples used in the abrasion studies. This method works by reconstructing the rope in three dimensions from a structure-from-motion approach. The method was able to generate significantly higher quality images from the 25 mm diameter ropes but was found to be a more challenging method to use for accurate dimension measurements as it does not give correct scale-to-real world measurements, as well as having some measurement artifacts. Examples of the resulting 3D images from the photogrammetry analysis are shown in Figure 12.

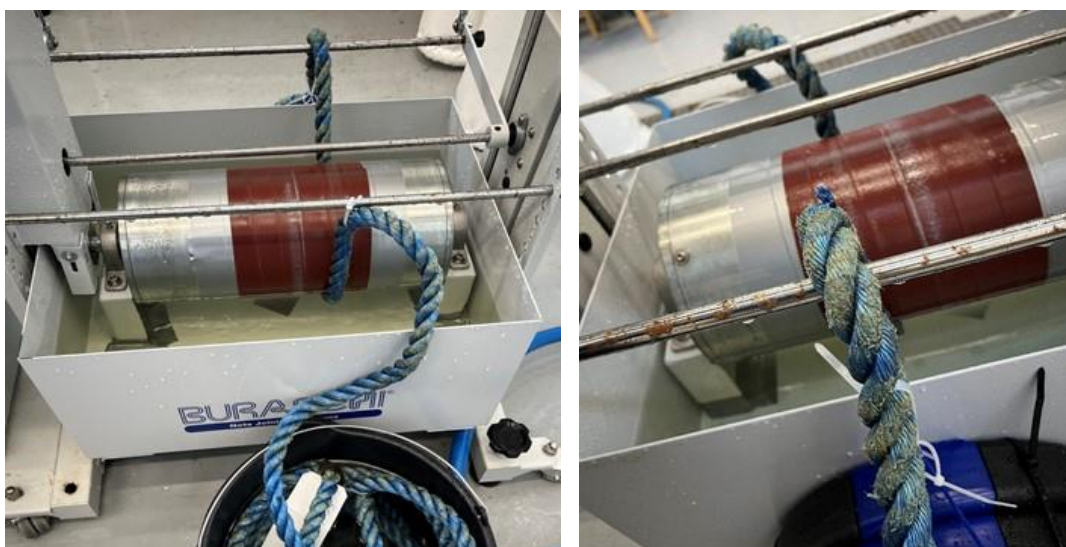
Figure 13: Set-up for rope abrasion test. The rope was fixed at one end (white cable tie in left picture), while two 5 kg weight discs were attached at the free end (right picture). In these pictures, the red abrasive band had been previously used, while for the presented result it was changed between each replicate test.

The abrasion protocol followed was analogous to that described for the net samples. Briefly, prior to each abrasion trial, the tank and pump system were thoroughly cleaned by flushing with freshwater for approximately three minutes. A new abrasive cloth band (220 grit) was installed on the drum before each replicate test to ensure consistent mechanical wear conditions. The water tank was filled with tap water at room temperature, and a blank (reference) sample was collected by circulating the water through clean filters to account for any background contamination from the system or materials. Each rope sample was installed in the abrasion machine with a pre-tension of 10 kg, applied using weights at the free end (Figure 13). During each test, the drum completed 20 rotations, followed by a 1.5-minute washing and filtration phase. Particles generated during abrasion were captured on two filters per replicate: a 300 μm filter for larger particles (MP_{LARGE}) and a 10 μm filter for smaller particles (MP_{SMALL}). Three replicate abrasion and filtration tests were performed for each rope material. Sample preparation and gravimetric analysis for the quantification of MP_{LARGE} and MP_{SMALL} particles was performed as described for the nets (see section 3.1.1).

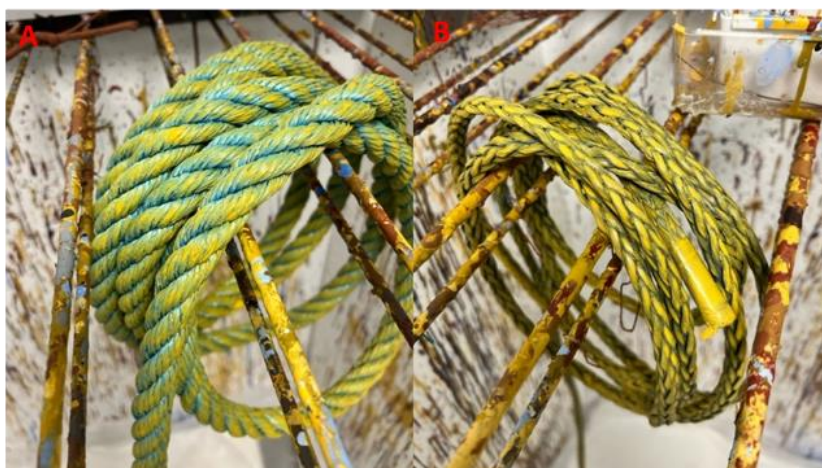
Figure 14: Examples of unsuccessfully coated polyolefin2 (A) and recycled polyolefin2 (B) with standard coating.

- The coatings did not adhere properly to the rope surfaces (Figure 14a, b).
- The coated ropes became excessively rigid, losing their functional flexibility and rendering them unsuitable for practical use in aquaculture applications.

Due to the abovementioned coating issues, it was concluded that applying coatings to ropes is not a viable strategy for reducing MP emissions from ropes. As a result, no experimental data on coated ropes are included in the Results section.

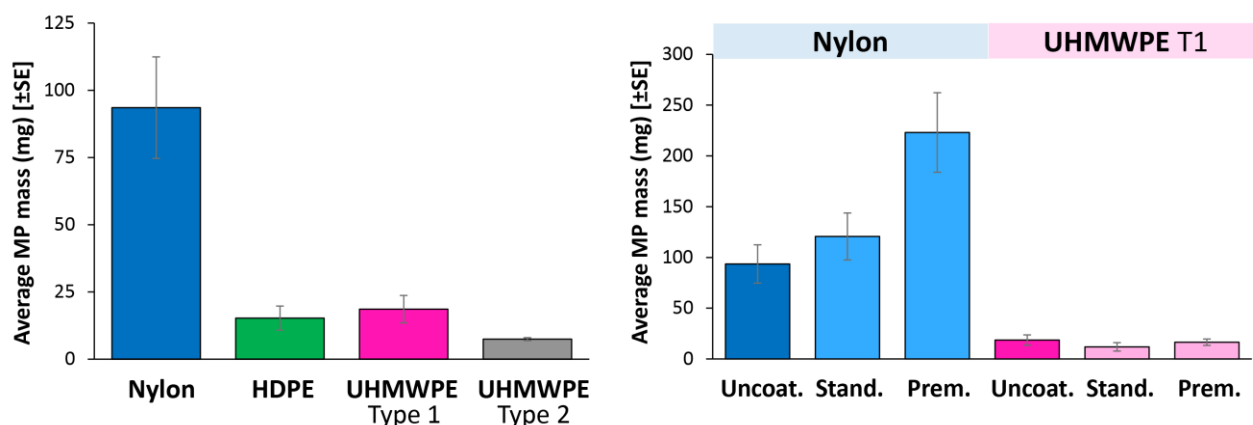
Figure 15: Average (n=3) MP release per net from four different new net materials (left), as well as from new nylon and UHMWPE type 1 nets (n=3) coated with Brynsløkken standard or premium coating (right).

The comparison of net materials revealed that nylon nets released nearly five times more MP on average (94 ± 19 mg MP, mean \pm standard error) than the three polyethylene-based (PE) net materials (based on mass), which showed MP releases ranging from 7 ± 0.5 to 19 ± 5 mg (Figure 15). When coatings were applied, MP release from nylon nets more than doubled with the premium coating (223 ± 39 mg), while the increase with the standard coating was less pronounced (121 ± 23 mg). In contrast, neither coating type led to an increase in MP release from UHMWPE nets (Figure 15). Although statistical significance was not achieved due to the limited number of replicates ($n=3$) and relatively high variability, consistent trends across materials were observed. These trends suggest meaningful differences in MP release that warrant further investigation. Visible wear was observed over a length of approximately 25 cm for the netting test panels, and over the whole width of about 35 cm.

Nylon netting appears to be less abrasion-resistant than the PE materials (HDPE and UHMWPE) tested in this study. While HDPE, UHMWPE, and nylon are generally known for their good abrasion resistance compared to other plastics, UHMWPE has consistently been shown to outperform nylon in many applications. Previous tests comparing nylon with PE nets (both HDPE and UHMWPE) have demonstrated that nylon experiences a greater reduction in strength under similar abrasive conditions and exhibits more visible signs of wear.¹⁴ For HDPE nets, the increased abrasion resistance may also be attributed to the use of significantly thicker monofilament fibres, in contrast to the much finer nylon multifilaments typically used in conventional netting.

Clear differences were observed in how the coatings interact with nylon and UHMWPE net materials. For UHMWPE, average MP emissions were similar across the uncoated, standard-coated, and premium-coated samples. This suggests that the coatings adhere well to UHMWPE, providing effective protection against abrasion due to both good adhesion and the inherent resistance of the coating material. This is supported by the fact that the UHMWPE net had a higher coating uptake than nylon (see Section 3.1.1). In contrast, the lowest MP emissions for nylon were recorded in the uncoated samples. While the standard-coated nylon net showed a moderate increase in MP release (not statistically significant), the premium-coated nylon net exhibited the highest emissions. These findings suggest that the coatings adhere less effectively to nylon than to UHMWPE, with the premium coating possibly showing the poorest adhesion, or simply providing more material to abrade off due to the thicker coating application. Alternatively, it may be that the coating penetrates more deeply into the strands of the UHMWPE net compared to nylon nets, where it adheres more superficially and was thus easier removed. It is important to note that the total MP measured for each sample includes contributions from both the coating and the net material.

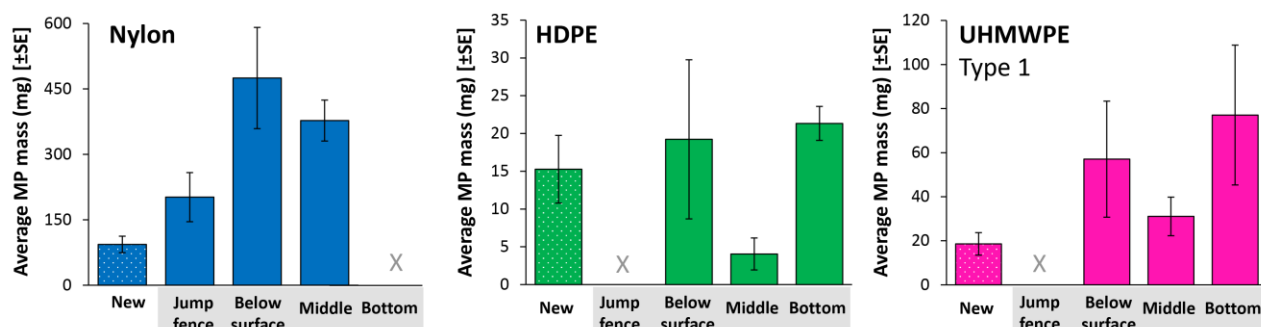
Figure 16: MP release per net from different regions of three different used net materials (grey underlay) in comparison to the same material when new (n=3). Three areas out of four possible spots in the used pen net were sampled for each material. (Note the different axis scales).

For nylon nets, a trend was observed indicating increased MP emissions from used nets (Figure 16). A similar, though less pronounced, pattern was also seen for the UHMWPE net. However, it is important to note that the UHMWPE net had been coated during its final season at sea, and some of the collected particles may have originated from the coating rather than the net material itself. Despite this uncertainty, both materials showed a consistent trend, where areas identified by service site personnel as being most prone to abrasion—such as sections just below the surface and at the bottom of the pen (see Section 4.1.4)—tended to have higher MP emissions compared to samples taken from the middle of the net.

A similar trend of higher emissions from areas below the surface and at the bottom compared to the middle was also observed for the used HDPE nets. However, overall MP emissions from the used HDPE nets did not

differ significantly from those of the new HDPE nets. One possible explanation for the absence of a clear trend for HDPE nets may be the age of the used net. While the nylon net samples came from an end-of-life net that was considered unfit for further use due to factors such as loss of strength, the HDPE net had not yet reached the end of its service life. Its likely better functional condition may have influenced the emission results and limited the ability to assess the impact of net age on MP release for HDPE.

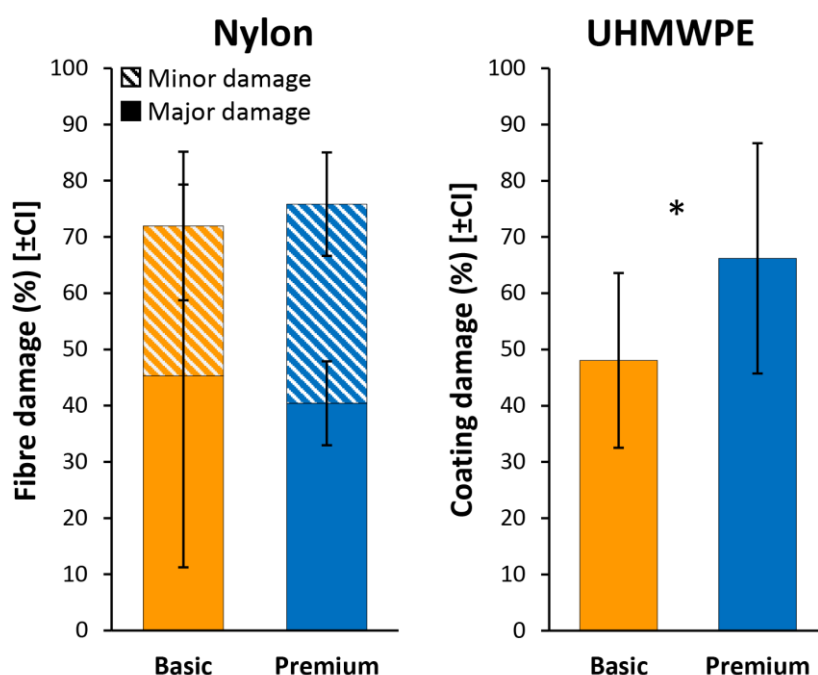
Figure 17: Assessment of coating and fibre damage for nylon and UHMWPE type 1 samples from the laboratory abrasion test (n=3). Significant differences in damage between materials are indicated by an asterisk.

The assessment of fibre and coating damage revealed no significant difference between the two coating types for nylon nets (Figure 17). On average, 72% of the surface of the nylon net with standard coating exhibited fibre damage, with major damage accounting for almost half (45%) of the assessed strands. For the premium-coated nylon net, 76% of the assessed strands showed damage, with major damage making up 40% (Figure 18). In contrast, UHMWPE nets did not show obvious fibre damage, but exhibited a difference between coatings. On average, the premium-coated UHMWPE nets showed greater coating damage (66%; Figure 18) compared to those with the standard coating (48%) ($F_{1,5} = 9.23$; $p_{MC} = 0.04$). It is unclear why the microscopic results do not align with the MP release measurements. It must also be noted that the assessment was limited to three replicates, and so interpretation of statistical results should be done with care.

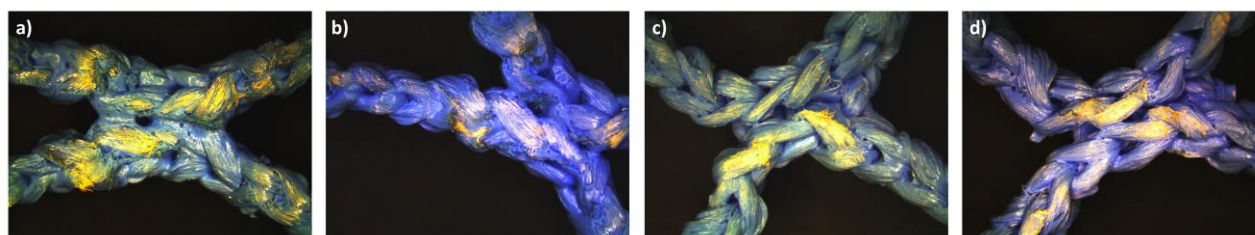
Figure 18: Examples of nylon (a + b) and UHMWPE (c + d) nets with premium coating showing signs of abrasion.

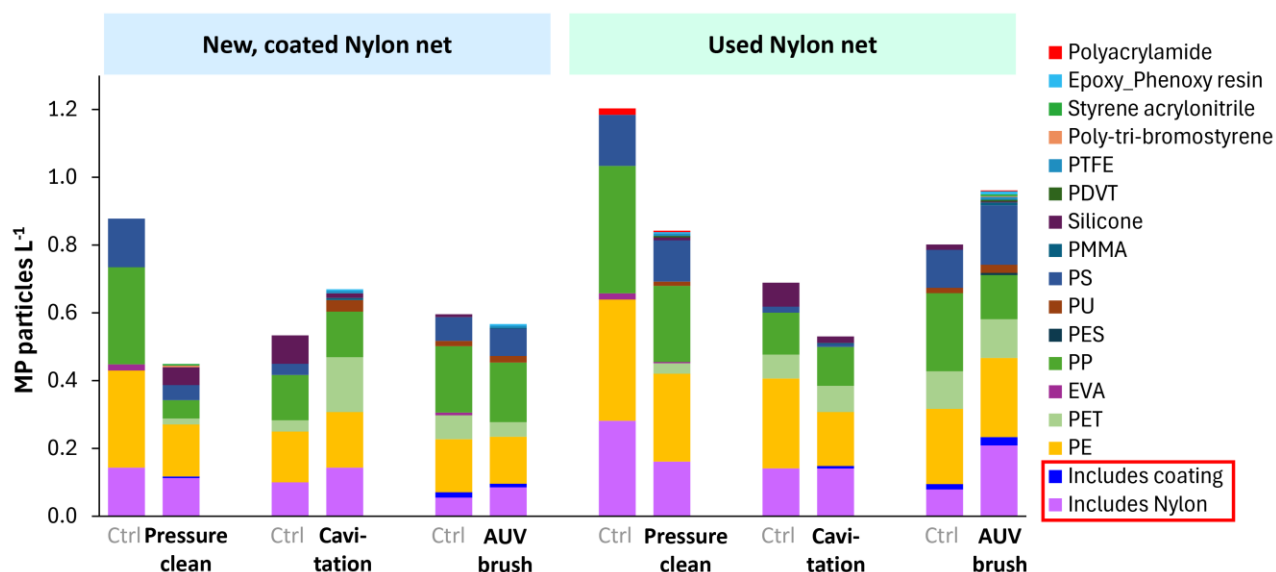
Figure 19: MP particles per Liter collected during the accelerated cleaning experiment.

No differences were observed in MP particle abundance between cleaning samples and control samples collected prior to cleaning, nor between the different cleaning technologies. In many cases, control samples showed higher total MP particle counts than the average values determined for the cleaning samples, with concentrations reaching up to 1.2 MP particles L⁻¹ (Figure 19). The collected particles were classified into 17 different material types, indicating a wide range of different polymer type MP particles were present in the collected water samples. The polymer composition of the net and coating material were known and represented just two polymer types; the results indicate that the water samples contain a diverse loading of MP that come from other sources. Interestingly, neither the nylon nor the coating material stood out as being dominant compared to the other types of polymer present.

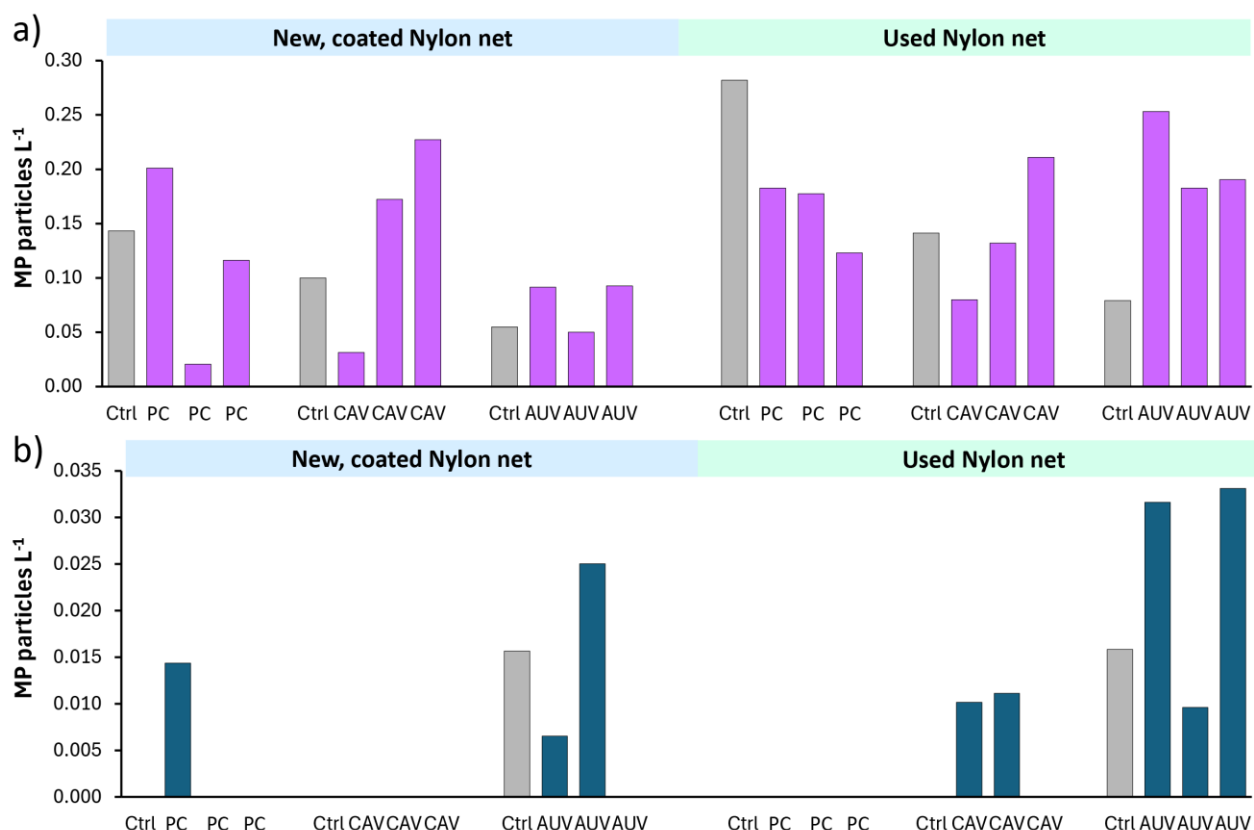
Figure 20: MP particles per Liter, belonging to the category that includes a) nylon nets and b) net coating; one control sample followed by three samples taken during net cleaning using three technologies (pressure cleaning (PC), cavitation cleaning (CAV) and AUV brushing (AUV)) on two net materials.

Of these, two categories were relevant for identifying particles originating from the nylon net or the coating. For both categories, MP abundance did not differ notably between the different cleaning technologies or the control (PERMANOVA for factors Technology and Coating, $p > 0.05$), ranging from 0.02 to 0.25 MP particles L⁻¹. In fact, the greatest variation was found among individual replicates of the same sample, rather than between different cleaning treatments. Focusing on the category that included nylon particles (Figure 20a), only one case showed consistently higher particle counts in the cleaning samples compared to the control: AUV brushing of the used nylon net. However, this result should be interpreted with caution, as pressure cleaning had previously been performed on this same net. When focusing on particles potentially originating from the coating (Figure 20b), only a few samples from coated net cleaning contained particles identified as coating-derived (3 out of 9 samples). For the used nylon net, this number was slightly higher (5 out of 9 samples), but concentrations remained very low—fewer than 3 particles per 100 L.

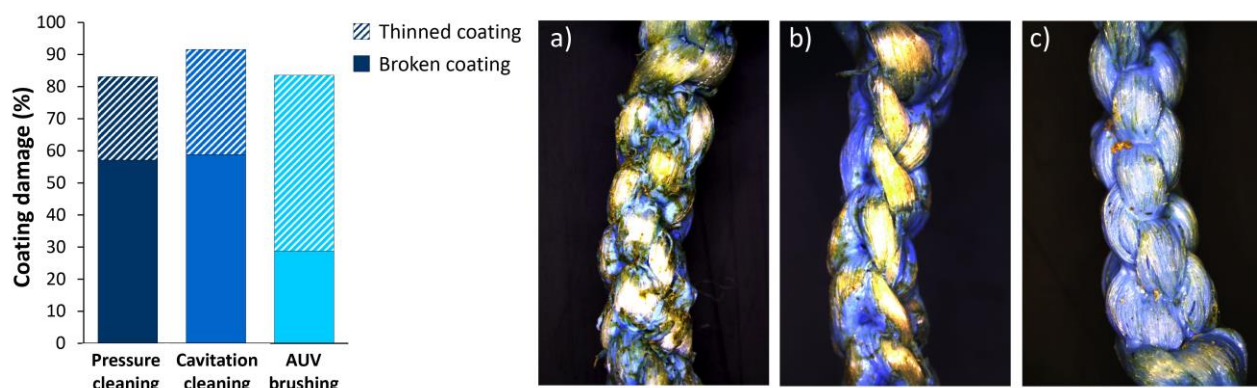
Figure 21: Results from microscopic assessment of coating integrity of new, coated nylon nets (n=3) after accelerated net cleaning using three different cleaning technologies, with examples of worst-case damage from: a) pressure cleaning; b) cavitation cleaning and c) AUV brushing.

In contrast to the challenges of collecting MP particles, the assessment of coating abrasion provided a clearer and more conclusive picture (Figure 21). While the total affected surface area did not differ significantly between cleaning technologies, with all three showing damage on 83–92% of the coated surface, differences emerged when the extent of damage was considered. Pressure and cavitation cleaning resulted in significantly higher proportions of broken coating (57% and 59%, respectively) compared to AUV brushing (29%) ($F_{2,8} = 6.18$; $p = 0.04$). Conversely, thinned coating was more prevalent following AUV brushing (55%)

than after pressure and cavitation cleaning (26% and 33%, respectively), with this inverse relationship also being statistically significant ($F_{2,8} = 22.46$; $p = 0.03$).

While conclusions based on only three replicates should be drawn with caution, clear differences in coating damage were evident under the microscope. AUV brushing appeared to remove the coating more uniformly across the surface (Figure 21c). Although coating integrity was still compromised in some areas, exposing the underlying nylon strands, the damage from pressure and cavitation cleaning was more severe, often resulting in sharp-edged breaks in the remaining coating (Figure 21a, b). However, how these differences translate into MP release remains uncertain based on the current data. One possibility is that AUV brushing generates smaller particles, whereas the other two technologies may cause the coating to splinter off in larger pieces. The implications of particle size for total MP release, as well as subsequent environmental transport and potential uptake by organisms require further investigation. Future studies should also consider that nets have distinct 'sides', with knots protruding on one side. In this experiment, pressure cleaning was conducted on the backside of the net (with protruding knots), cavitation cleaning on the front side, and AUV brushing operated on both sides. Although microscopic assessment included both sides—since damage was observed even on the 'unwashed' side—the influence of cleaning direction or side preference on the results cannot be determined from this study alone and require further investigation.

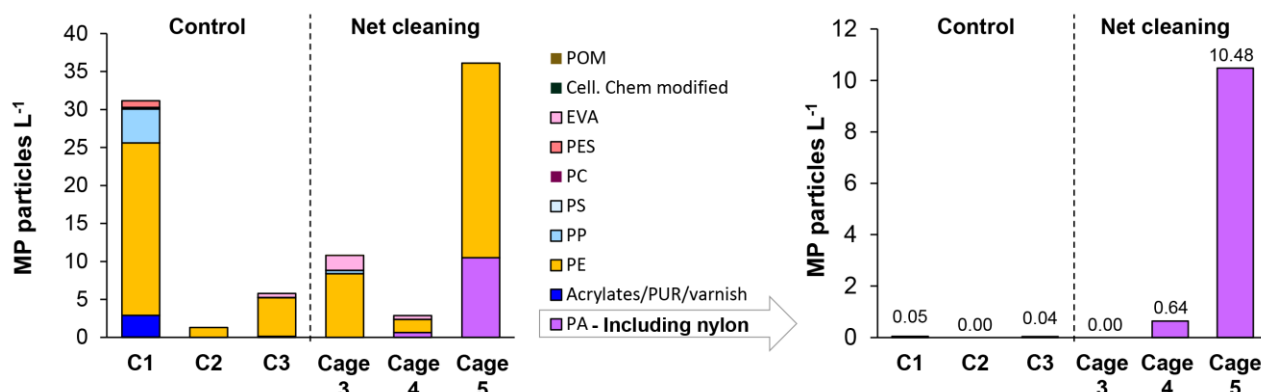
Figure 22: The number MP particles per Liter in water samples collected during an in-situ net cleaning operation using conventional pressure washing (Cage 3-5) and in control samples (C1-3) collected the day before. In addition, data for the fraction that may contain nylon particles is presented individually (on the right).

respectively). Control samples reached a similar range of concentrations with values between 1.3 and 31.1 particles L⁻¹.

The reason for the increased MP release measured at Cage 5 may be the lack of lice skirt. Lice skirts have been shown to retain particles inside the skirt volume compared to below,¹⁶ indicating a delayed release and lack of distribution through the skirt walls. Without the presence of a lice skirt in Cage 5, it is suggested that MP were able to disperse more quickly and more widely around the cage during cleaning, increasing concentrations also around the sample intake point. In comparison, the sample collection point for Cages 3 and 4 was approx. 3 m above the lice skirt edge. In these cages, the MP particles may have taken longer to disperse higher up in the water column or, for negatively buoyant polymer particles, may not have reached the sample intake point at all.

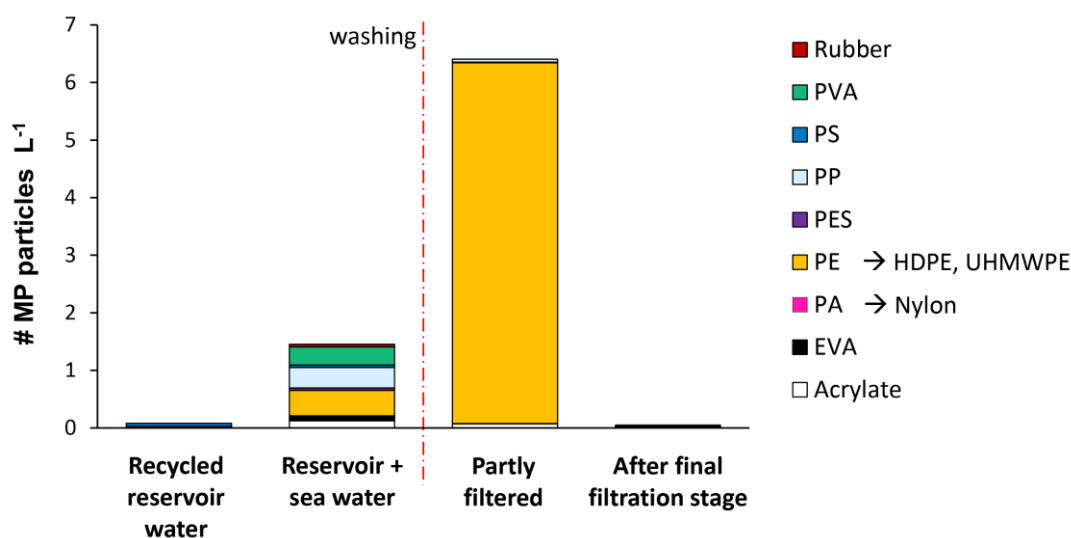
Figure 23: MP particles collected from different stages of the filtration unit associated with the drum washer. Presented data were subjected to blank correction by subtracting the particle count detected in the air-procedural blank.

Analysis of the water collected from the filtration unit revealed substantial variation between the four samples. The water in the reservoir supplying the drum washer had a very low particle concentration prior to the addition of fresh seawater (0.08 MP particles L^{-1} ; Figure 23). However, following the addition of fresh seawater, the total particle concentration increased significantly to 1.45 MP particles L^{-1} . This rise in MP concentration could be attributed to MP already present in the incoming seawater. Alternatively, the influx of water may have disturbed particles previously settled in the reservoir tank. Since no sample of the fresh seawater was taken for comparison, it is not currently possible to determine the exact cause of the increase in MP.

After net cleaning began, the sample taken from the partially filtered water showed a high concentration of PE particles. However, the net being washed at the time was made of nylon, suggesting that the detected particles likely originated either from the previously washed UHMWPE net or from a cleaner fish shelter being washed in an adjacent unit connected to the same filtration system. The final sample, taken from the filtration unit just before the water was treated with ozone and either recirculated to the reservoir tank or released into the sea, had the lowest measured MP particle concentration—0.05 MP particles L⁻¹ (5 particles in a 101 L sample). Given that control samples collected at sea showed average concentrations as high as 18.4 ± 8.6 MP particles L⁻¹, this can be considered a low MP concentration. Although this conclusion is based on a single sample, the filtration system appears to be effective at removing the majority of MP particles ≥ 10 μ m in size.

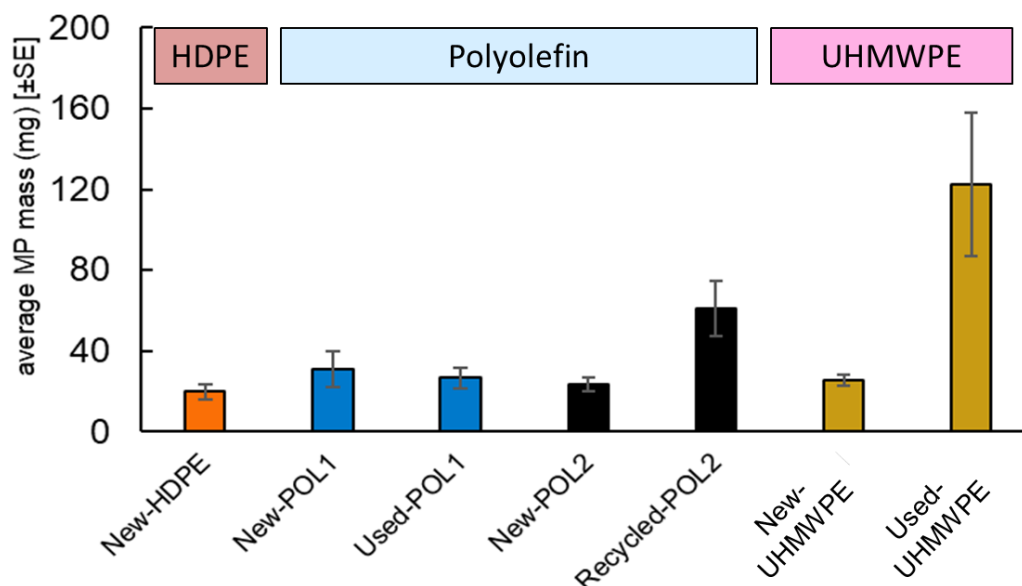
Figure 24: MP release per rope from 5 different new rope materials (including 50% recycled polyolefin), as well as from used polyolefin and UHMWPE ropes.

from the used UHMWPE rope material itself (without coating) cannot be directly compared to MP from new rope, and there is no evidence that the UHMWPE MP release is increasing with use (or the opposite).

The tested ropes were primarily standard ‘off-the-shelf’ ropes, with the exception of the recycled rope that represented an example of a sustainable product entering the market. The ropes used in the study all had different structures, including the lay of the rope, rope thickness and mass per length, fibre geometries and raw material (Figure 10). With such a high number of varying parameters across the different ropes tested, it is impossible to evaluate the effect of specific parameters on MP release. For example, comparing the HDPE rope with the polyolefin1 rope, we see that the HDPE rope is thinner, has thicker fibres, and a lower strength. The results in Figure 24 suggest that the HDPE rope has a slightly lower MP release than many of the other ropes, but it is not possible to point to the parameter(s) that may have caused this. It could be related to the different raw materials, the different rope and fibre thickness, or combination of these factors. To study the effect of the lay of rope or rope thickness, for example, specific tests focusing on varying the selected parameter alone must be performed. Thus, this test conducted in the current study should be considered as a comparison of specific ropes and not rope properties.
